EXPERT INSPECTION · EN 15635

## Racking inspection report

# DC München-Freimann

| Report number | RPT-2025-0131 |

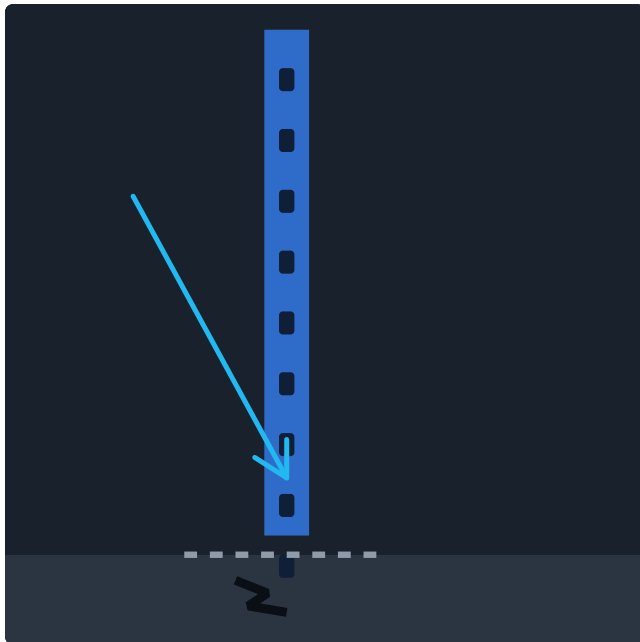
**F1 · E-02 · L0 · left**  
Base plate — Missing part

| LOCATION | COMPONENT · DAMAGE | MEASURED | LIMIT USED | CLASS · DUE | PHOTOS |
|---|---|---|---|---|---|
| F1<br><b>E-02</b><br>L0 · left | <b>Base plate</b><br>Missing part | — | <b>Immediate red condition</b><br>baseplate.missing<br>EN 15635 · 9.5 | <b>! Red</b><br>due at once | |

**Observation** Base plate missing under front left upright; upright standing on the slab.

! Red

**Action** Offload the affected bay at once and isolate the area. Do not reload until the damaged component has been replaced and a competent person has re-checked the installation.

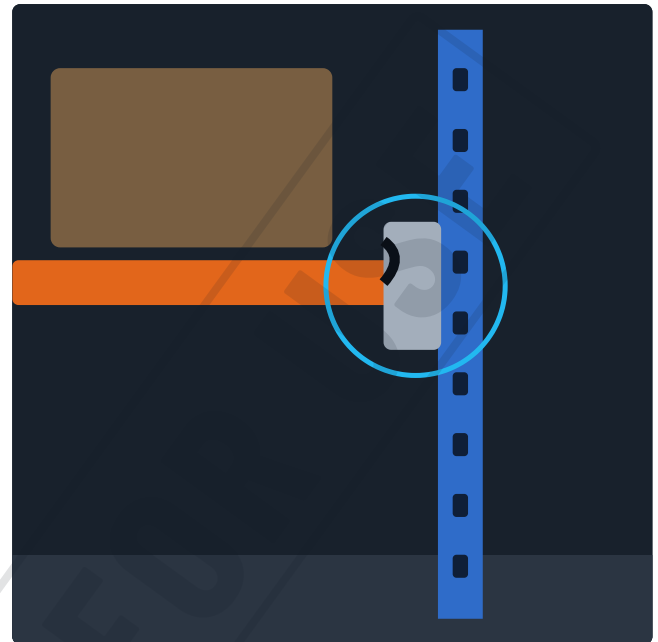
**F2 · A-07 · L2 · right**  
Beam connector — Bend or bow

| LOCATION | COMPONENT · DAMAGE | MEASURED | LIMIT USED | CLASS · DUE | PHOTOS |
|---|---|---|---|---|---|
| F2<br><b>A-07</b><br>L2 · right | <b>Beam connector</b><br>Bend or bow | — | <i>Inspector judgement</i> | <b>! Amber</b><br>due 20 Nov 2025 | |

**Observation** Connector hooks deformed; beam still seated. Repeat impact zone.

| BAY · LEVEL | COMPONENT | PREVIOUS CLASS | RE-CHECK | THIS INSPECTION |
|---|---|---|---|---|
| A-07 · L2 | Beam connector | ✔ Green | Worse | ⚠ Amber · F2 |

! Amber

**Action** Offload and do not reload until repaired. Replace the damaged component with a part specified by the manufacturer by the due date; if it is not repaired by then, treat it as red.

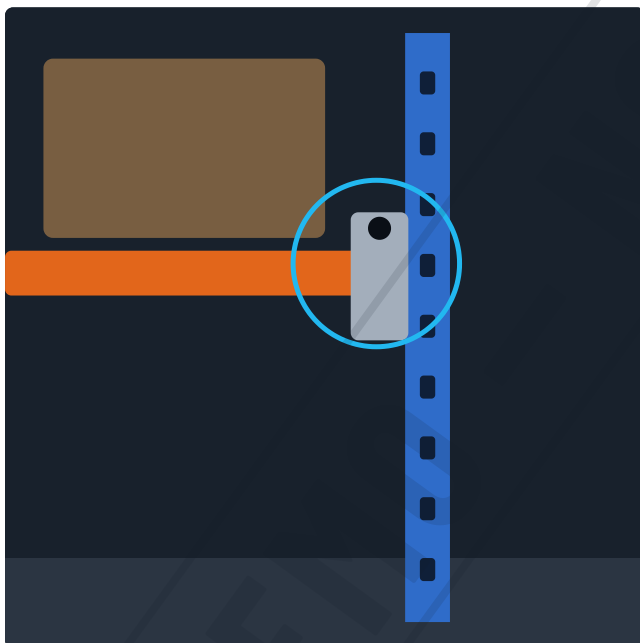
**F3 · B-04 · L3 · right**  
Safety lock — Missing safety lock

| F3<br><b>B-04</b><br>L3 · right | <b>Safety lock</b><br>Missing safety lock | — | <i>Inspector judgement</i> | <b>! Amber</b><br>due 20 Nov 2025 | |

**Observation** Safety lock missing on right connector.

! Amber

**Action** Offload and do not reload until repaired. Replace the damaged component with a part specified by the manufacturer by the due date; if it is not repaired by then, treat it as red.

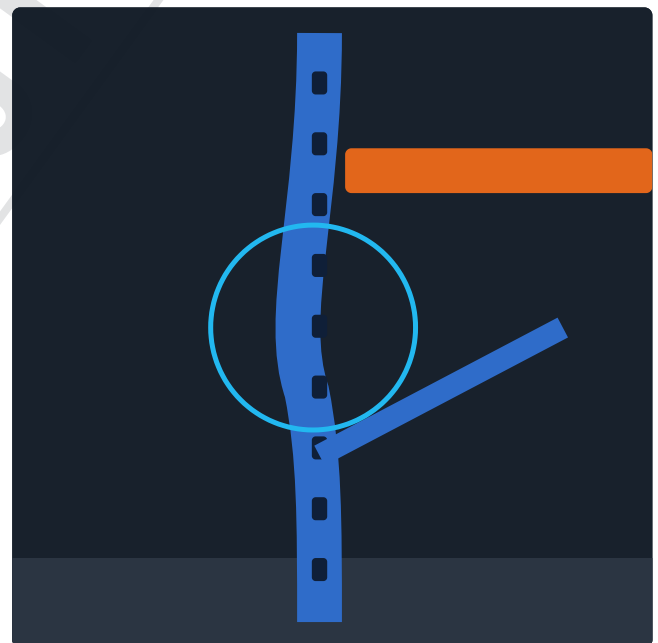
**F4 · E-09 · L1 · right**  
Upright — Bend or bow · Down-aisle · front face

| LOCATION | COMPONENT · DAMAGE | MEASURED | LIMIT USED | CLASS · DUE | PHOTOS |
|---|---|---|---|---|---|
| F4<br><b>E-09</b><br>L1 · right | <b>Upright</b><br>Bend or bow<br>Down-aisle · front face | <b>2.8 mm</b><br>bow over 1 m | <b>999 mm (demo)</b><br>upright.bow.axisA<br>EN 15635 · 9.5 | <b>Amber</b><br>due 20 Nov 2025 | |

**Override** suggested Green → set Amber: combined damage — Bend sits at a bracing node; combined damage.

Correction: finding E-09 is on the front right upright, not front left. Classification unchanged.

! Amber

**Action** Offload and do not reload until repaired. Replace the damaged component with a part specified by the manufacturer by the due date; if it is not repaired by then, treat it as red.

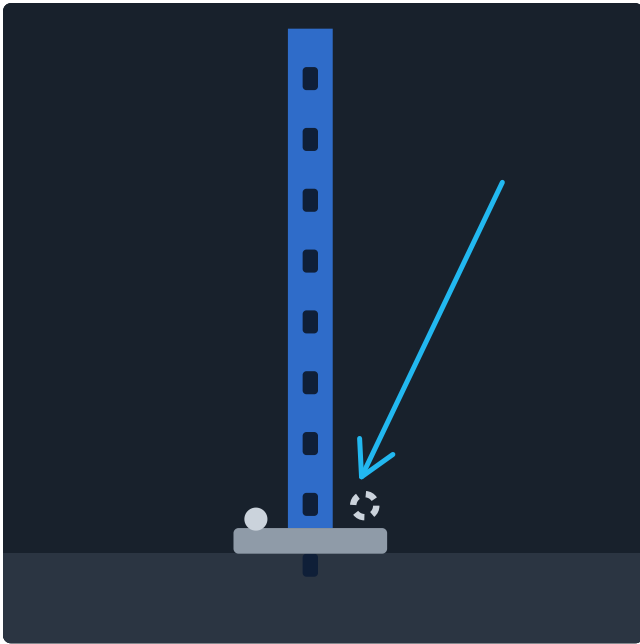
**F5 · F-06 · L0 · right**  
Floor anchor — Loose or missing anchor

| F5<br><b>F-06</b><br>L0 · right | <b>Floor anchor</b><br>Loose or missing anchor | — | <i>Inspector judgement</i> | <b>Amber</b><br>due 20 Nov 2025 | |

**Observation** Anchor missing at rear right base plate.

⚠ **Amber**

**Action** Offload and do not reload until repaired. Replace the damaged component with a part specified by the manufacturer by the due date; if it is not repaired by then, treat it as red.

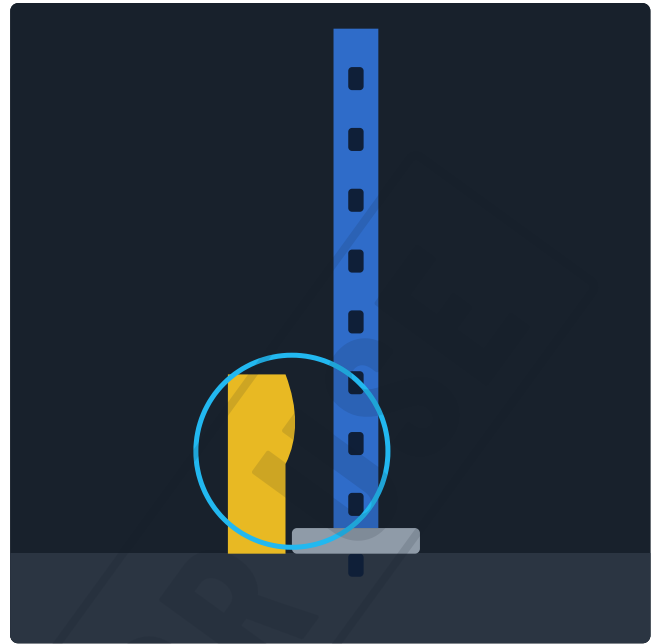
**F7 · C-12 · L0 · left**  
Upright protector — Dent

| F7<br><b>C-12</b><br>L0 · left | <b>Upright protector</b><br>Dent | — | <i>Inspector judgement</i> | <b>Green</b><br>no due date | |

**Observation** Upright protector dented; upright behind it undamaged.

✓ **Green**

**Action** Record and monitor. Re-check at the next inspection.
